Experimental assessment of low velocity impact damage in flax fabrics reinforced biocomposites by coupled high-speed imaging and DIC analysis

Karthik Ram Ramakrishnan, Stéphane Corn, Nicolas Le Moigne, Patrick Ienny,
Pierre Slangen

Karthik Ram Ramakrishnan, Stéphane Corn, Nicolas Le Moigne, Patrick Ienny, Pierre Slangen. Experimental assessment of low velocity impact damage in flax fabrics reinforced biocomposites by coupled high-speed imaging and DIC analysis. *Composites Part A: Applied Science and Manufacturing*, 2021, 140, pp.106137. <10.1016/j.compositesa.2020.106137>. <hal-02959295>

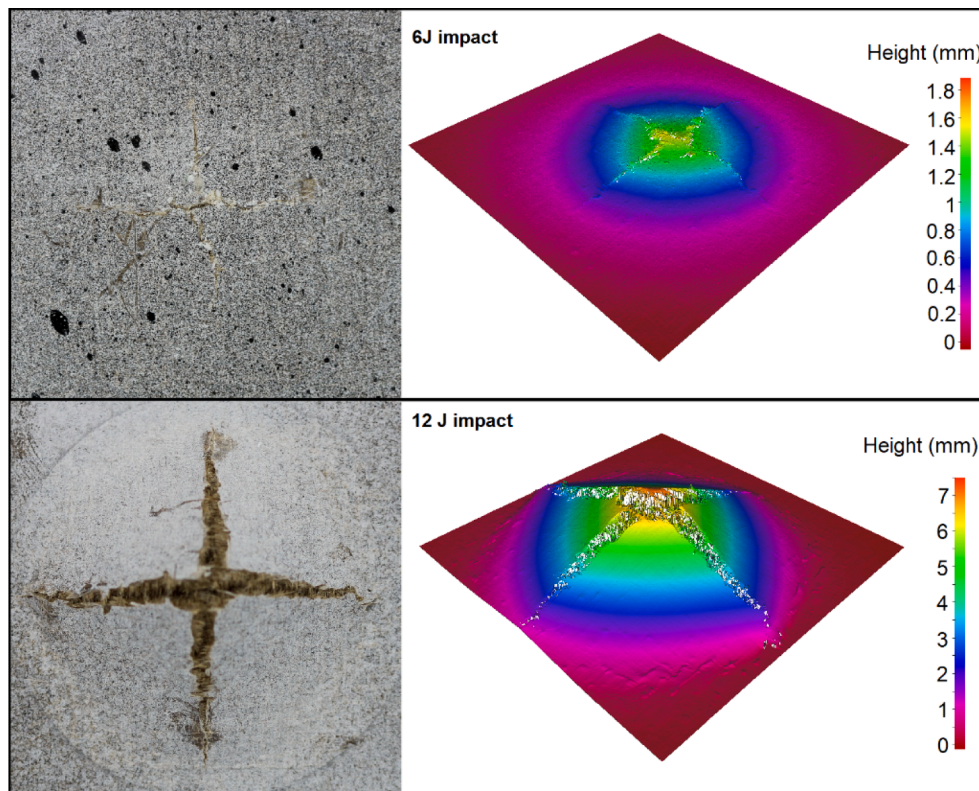
Fig. 9. Visual and profilometer image of post-impact deformation in flax-PP composite after 6 J and 12 J impact.

A comparison of the visual inspection of the bottom surface of the flax-PP composite samples impacted at energies of 6 J and 12 J is shown in Fig. 9. The profile and topography of the indentations produced by the impact were analyzed by measuring the depth and width of the surface deformations from the Alicona profilometer. Since the polypropylene matrix is a ductile material, extensive deformation is observed in the flax-PP composite as evidenced by the bulged surface and fibre pull-out in the profilometer images. The peak residual deformation of 1.8 and 7.5 mm are observed for the plates impacted at 6 J and 12 J respectively. At lower energies, there is matrix cracking around the point of impact and as the energy of impact increases, fibre fracture forms a crack that is aligned with the fibre directions of 0 and 90°. There is extensive fibre failure of the composite for initial energy of 12 J for the flax-PP composite and it can be seen that the crack nearly reaches the edge of the

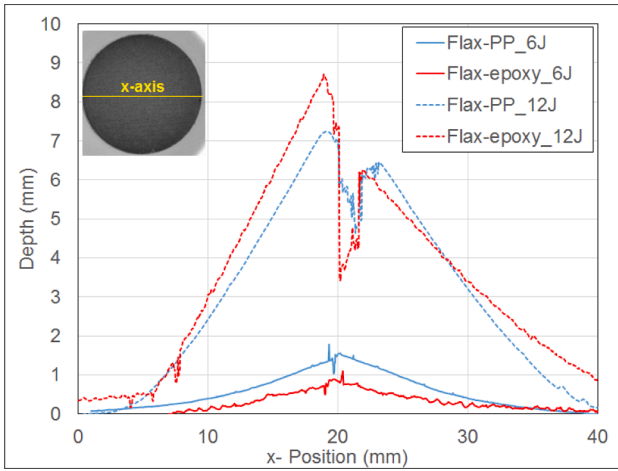
Fig. 11. Depth profile for flax-PP and flax-epoxy composites after 6 J and 12 J impact.

The depth profiles of the rear of the impacted plate obtained from the profilometer is compared for the 6 J and 12 J impacts of flax-PP and flax-epoxy composites in Fig. 11. Since the deformation of the plate is symmetric, the depth is plot along the central line of only one axis. It can be seen that the depth is highest at the center of the impacted area (20 mm), with 0 and 40 mm representing the clamped edge. The overall depth profile is similar for the flax composites with PP and epoxy matrix but it can be seen that the epoxy composite has less permanent deformation than the ductile PP matrix for the 6 J impact while at the higher energy there is complete perforation in both plates seen as discontinuities in the depth profile.

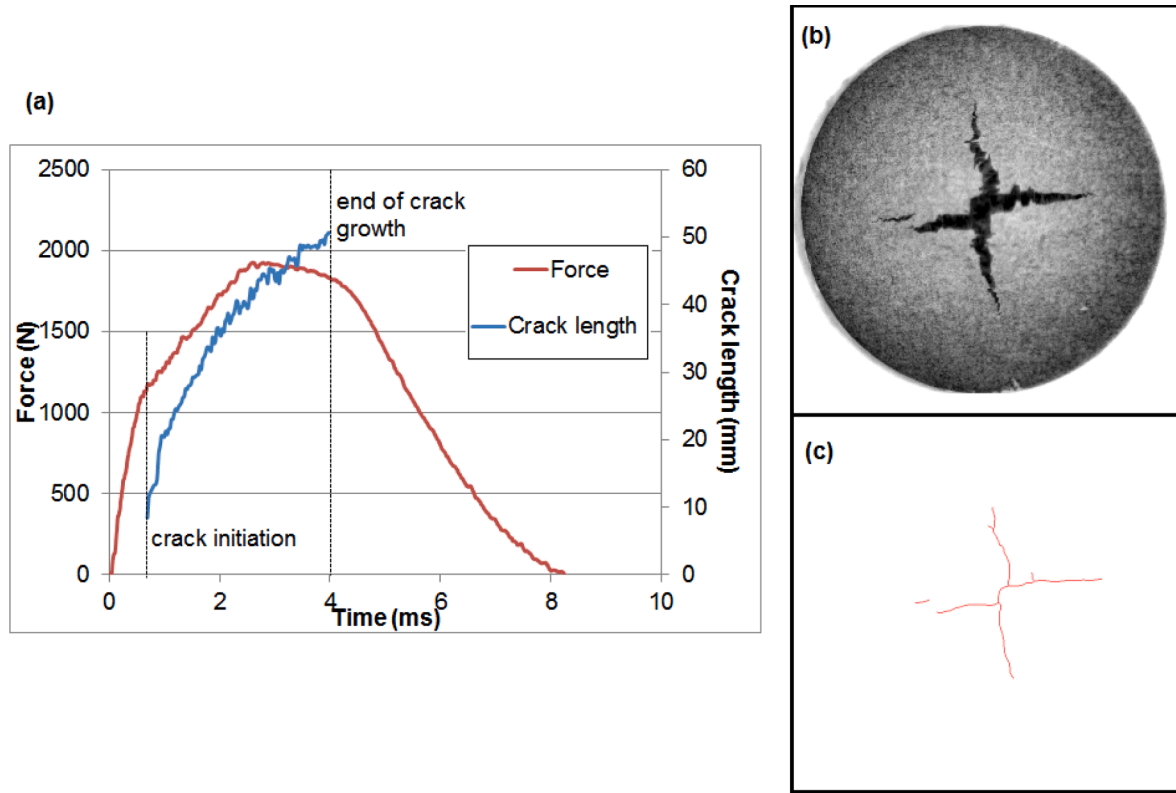
Fig. 17. (a) Force – displacement curves for 6 J impact on Flax-PP composite, along with total crack length; (b) Real time high-speed image of the plate at maximum crack length; (c) Skeletonised image of the crack.

Fig. 17 shows the evolution of cumulative crack length correlated to the force-time history obtained from the sensors. The force response exhibits an initial linear region followed by softening phase where the stiffness changes and it can be observed that the initiation of crack corresponds to the stiffness change at critical force of 1100 N. The crack length continues to increase as the crack propagates along the principal directions and reaches a maximum at the end of the loading phase. It should be noted that this is the total crack length and not the length of each radial arm. The kinematics of the crack propagation can be observed with this crack tracking method which is a significant difference to published literature such as Sy et al. [16] who only report the
